# Quaternary Geology and Landslide Dam Hazard Assessment of the Shotover Gorge, Otago

A thesis submitted in partial fulfilment  
of the requirements for the degree of

**Master of Science**  
**in Disaster, Risk and Resilience**

at the  
University of Canterbury

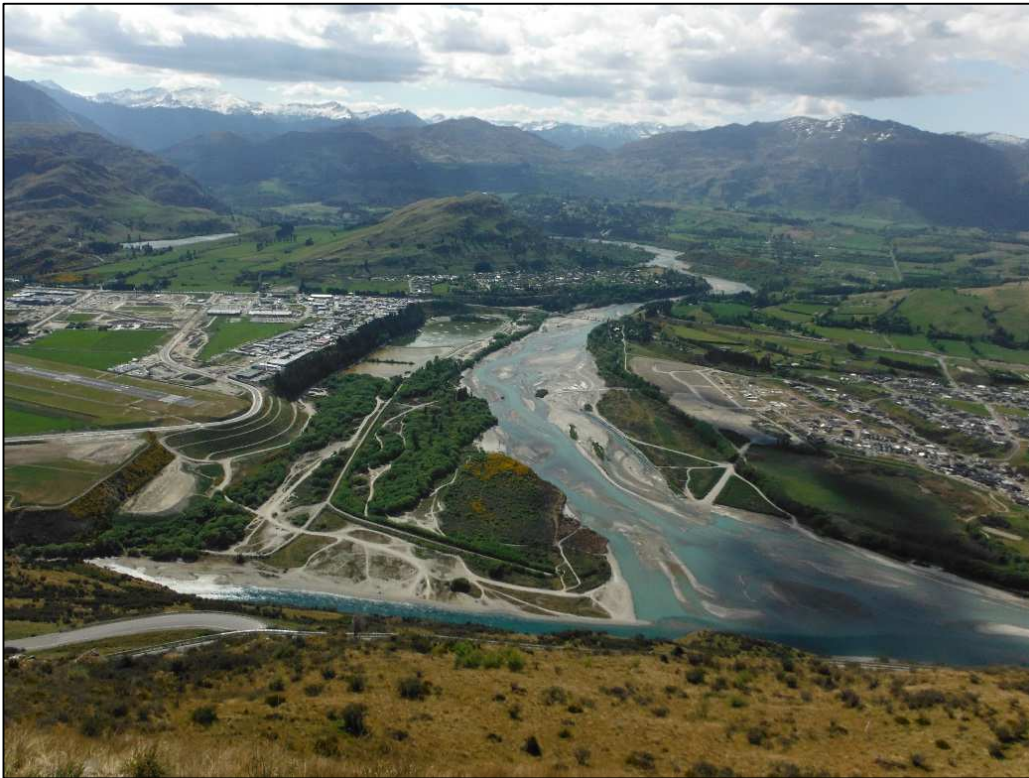
**Figure 1.10:** The Shotover delta viewed from the Remarkables Range, the active channel width is 200-350 m, and the delta is about 2 km in length. The river is incised within older post-glacial delta surfaces at Frankton (left) and Ladies Mile (right). The hill in the middle distance (Ferry Hill) is interpreted as a *roche moutonnee* (Cunningham 1994). The Shotover Country development can be seen in progress located to the right (east) of the Shotover Delta (photo taken in November 2017).

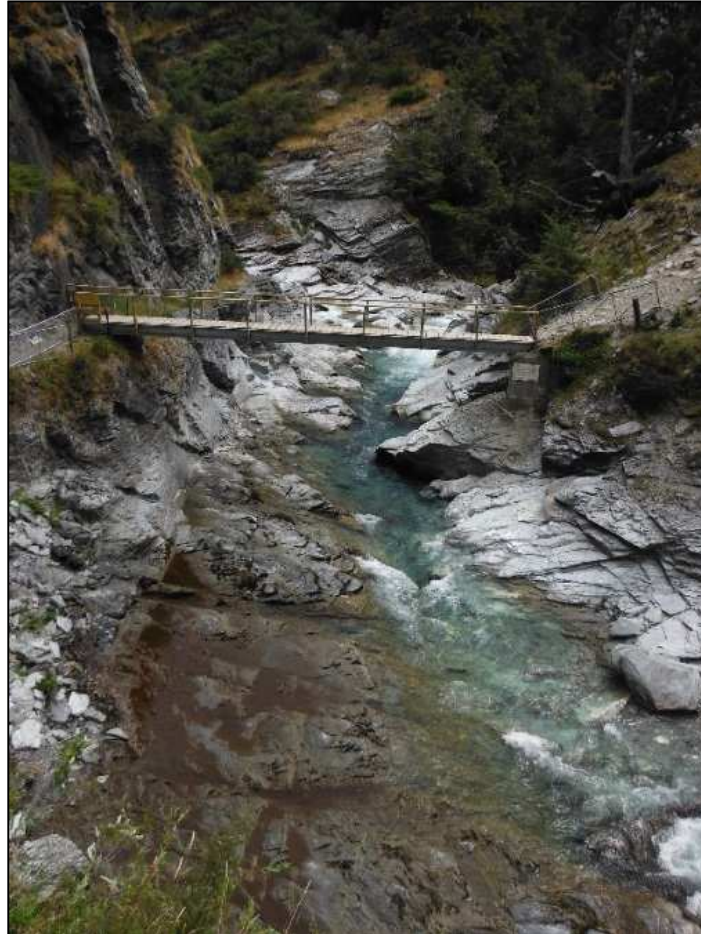
**Figure 2.3:** Lower Moonlight Creek looking upstream towards the Moonlight-Moke Creek confluence (behind footbridge), with Moke Creek entering from the upper left of image. This shows the Moonlight channel incising into bedrock and contrasts with the often alluvium-filled Shotover riverbed. Footbridge is 15-20 metres in length.

Moonlight Creek runs in a narrow gorge for ~1.5 km upstream from its confluence with the Shotover, it has little alluvial gravel and is incising into bedrock (Figure 2.3). For the next 5-6 km upstream the creek flows in an incised gorge with common beach sections, below large bedrock and alluvial terraces, similar to the Shotover River in the Skippers area.

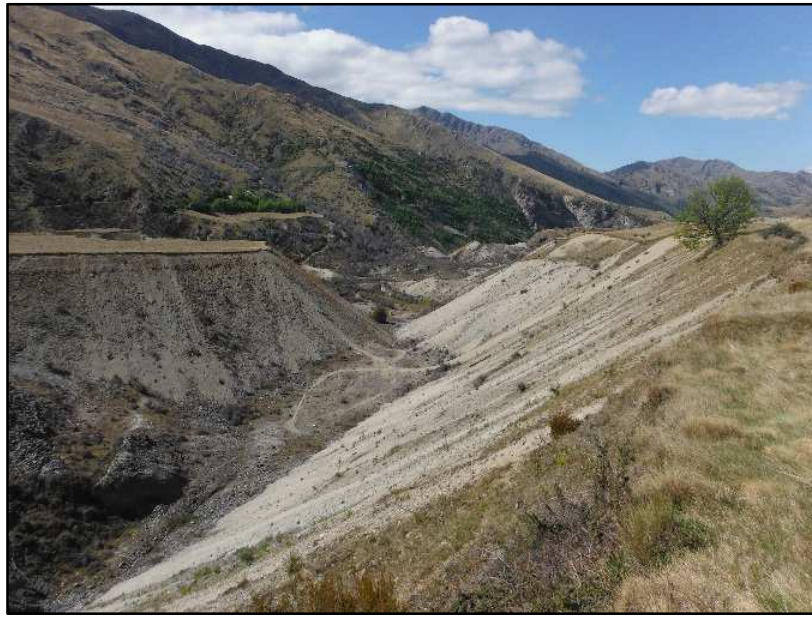
**Figure 2.9:** View to south through Pleasant Creek sluicing excavation showing >30 m thickness of alluvial gravels. Sluiced cut is 40-50 metres deep, and 150-180 metres wide. Schist outcrops near base of cut (left) mark approximate base of alluvium and location of interpreted bedrock paleochannel.

The extensive terrace gravels in the Shotover Gorge and Moonlight Creek (e.g. Figure 2.9) are interpreted as being remnants of an aggradation deposit. This terrace surface is approximately parallel to the modern channel gradient (Figure 2.26) and is thus interpreted as forming under a comparable sediment supply, and as a result of a significant rise in the valley's base level. This rise in base level is interpreted as being a consequence of the early-LGM Wakatipu Glacier intruding into and blocking the lower Shotover Gorge (Figure 3.8A). A glacially-induced base level rise as an aggradation cause contrasts with many other locations, where outwash aggradation is generally attributed to increases in sediment supply during glacial advance.

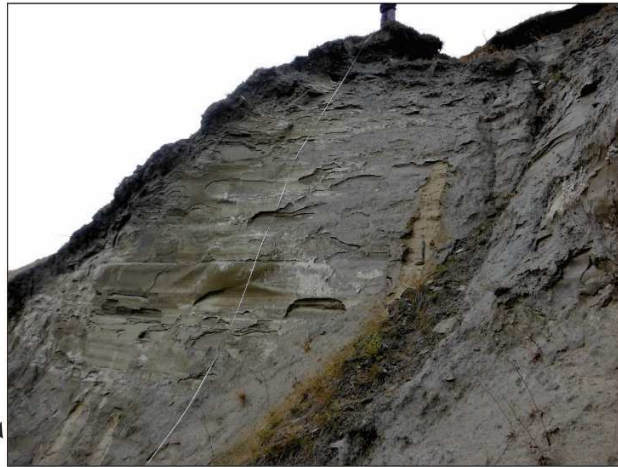
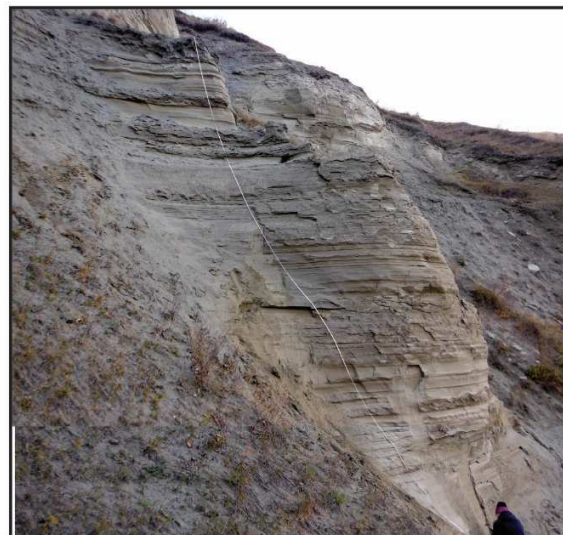
# **Strohles Flat** Upper Shotover Gorge

**Figure 2.12:** Strohles Flat stratigraphic section. The two upper inset photos show examples of well-bedded sand units. Lower inset photo shows the section location. Logging codes and location coordinates are shown in Table 2.1.

The main west-facing lacustrine sediment outcrop is about 50 m in width, with an upper elevation of about 570 m, overlain by a ~50 m thickness of fan gravels deposited by Rapid Creek. A stratigraphic log was completed for the centre of this exposure (Figure 2.12), which extended to the top of main sand units at about 574 m, but did not include the overlying gravels which continue to an elevation of about 620 m. Sediments consist of planar bedded sands, commonly with flame structures. Minor silts and gravels occur in the upper parts of the section. This is interpreted as a remnant of a lacustrine fan-delta deposit, similar to those observed at Ironstone and Stockyard Creeks (Chapter 3).

An extensive paleolake has been identified in the upper Shotover Gorge and Branches Flat, based on the occurrence of thick sequences of lacustrine and deltaic sediments (e.g. Figures 2.12, 2.16, 2.17). The lake is interpreted to have had an upvalley extent of >20 km (Figure 3.5), and to have persisted for at least several thousand years. The timing of lake formation has been constrained by a single OSL sample from deltaic deposits at Ironstone Creek, dated to ~25 ka (Figure 3.6). Forming relatively soon after the Sandhill Advance, the lake is interpreted to have formed as a proglacial lake during ice retreat, impounded by a barrier comprising outwash material in the upper Shotover Gorge (Figures 3.4, 3.8B). The rapid glacier retreat is interpreted to be due to ice-lake dynamics, as glacier behaviour becomes decoupled from climatic influences as a floating ice-front is formed (Shulmeister 2017). The formation of a large proglacial lake in the Shotover Valley is consistent with the typical behaviour of New Zealand valley glacier systems, where proglacial lakes impounded by outwash fan heads are a characteristic feature (Shulmeister 2017).

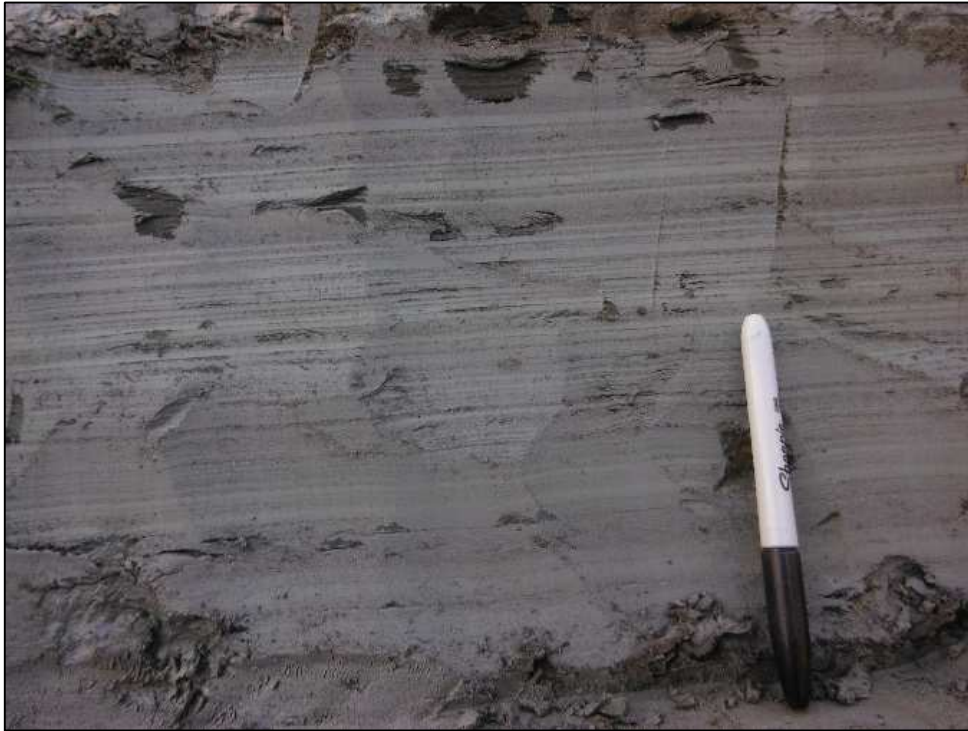
**Figure 2.15:** Example of mm-cm scale laminar bedded clay-silt and fine sands from outcrop at the Campbell's Saddle footbridge.

At the Campbell's Saddle footbridge (Figure 2.14) is an outcrop of, subhorizontally bedded lake sediments. These are finely laminated fine-medium sands and clay-silt (Figure 2.15) and contain flame structures and contorted bedding.

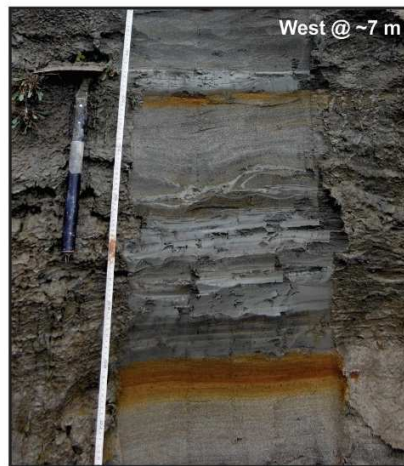
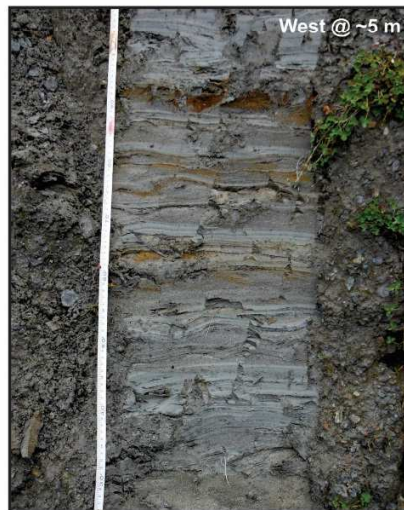
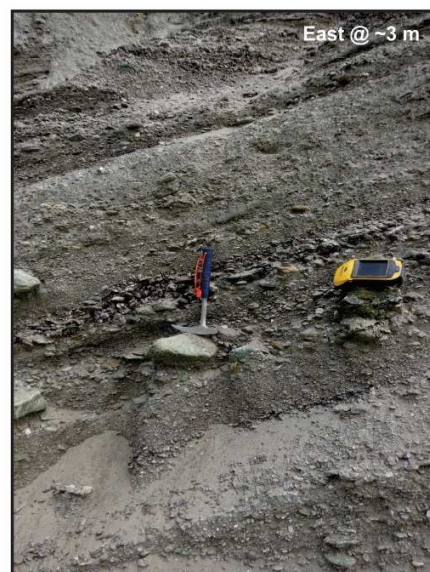
## Ironstone Delta Lower Branches Flat

The Ironstone Delta outcrop (Figure 2.16) shows a transition from inclined, imbricated, gravel-dominant units nearer the valley margin (east), to interbedded silts-sands on the western side. Stratigraphic sections were logged on lower (west) and upper (eastern) parts of delta (Figures 2.16, 2.17). Sediments in the western section are dominantly subhorizontal, interbedded silt-sands (Figure 2.17 inset), with minor gravel units. These are interpreted as fine grained facies of delta deposits. The eastern delta section is composed of inclined ( $18-22^\circ$ ), cm-scale bedded gravels deposited as progradational foreset beds (Figure 2.17 inset). These are overlain by a 10-15 m thickness of shallower lying bottomset silts/sands/gravels.

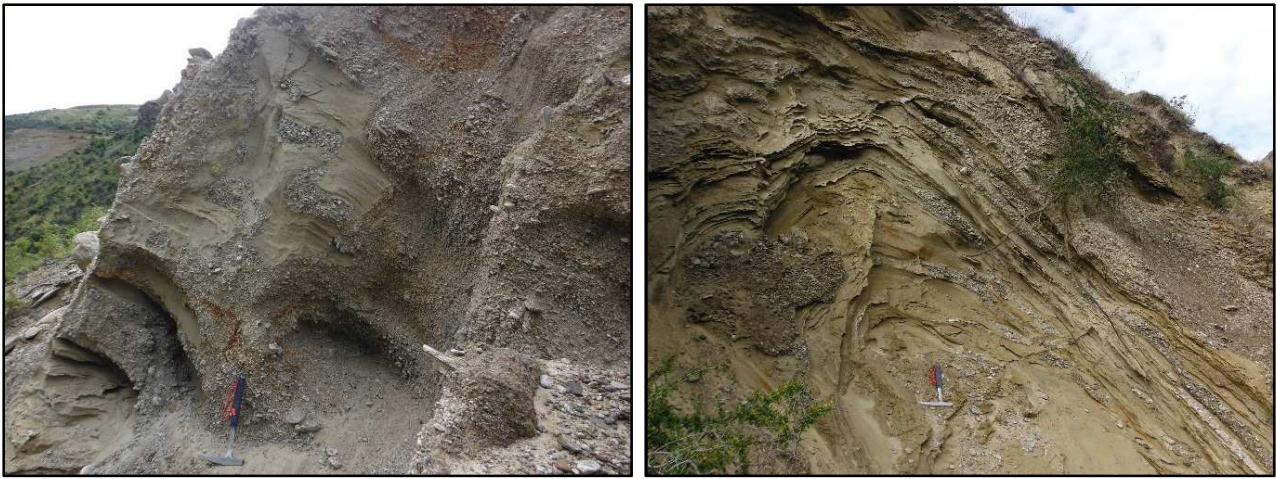
**Figure 2.18:** Examples of highly deformed glacial sediments at Sloan's Flat roadside outcrop.

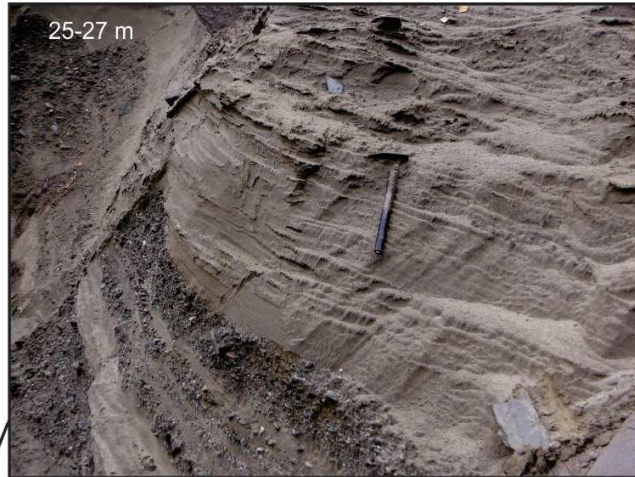
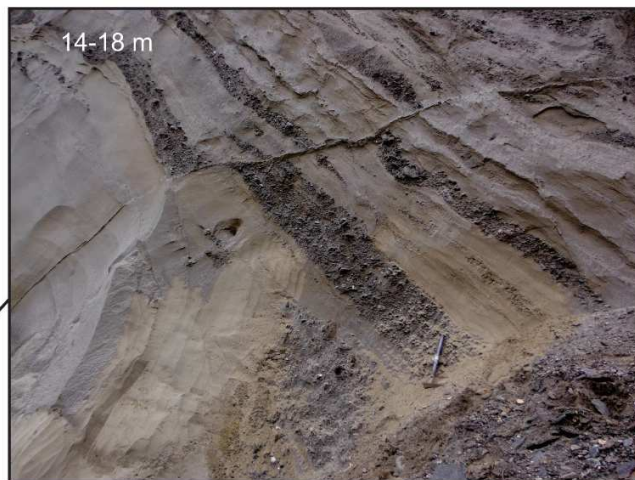
## Sandhill Creek Upper Shotover Gorge

**Figure 2.25:** Sandhill Creek stratigraphic section, logged at the location shown in Figure 2.24. Logging codes are shown in Table 2.1.

Glacial sediments in the upper Shotover Gorge (e.g. Figures 2.24, 2.25) are interpreted as forming in a proglacial fluvial environment, and reverse-sense glacetectonic deformation indicates formation in an ice-contact location (Figure 2.26). The glacial advance is interpreted to have reached to about Sandhill Creek (Figure 3.8A), and is named the 'Sandhill Advance' after Thompson (1998). Optically Stimulated Luminescence (OSL) dating of two bedded sand units from an outcrop of glacial sediments at Sandhill Creek shows these were deposited at ~29 ka (Figure 3.2). This early-LGM date (late MIS3/early MIS2) (Figure 3.9) is consistent with formation during New Zealand's maximum LGM ice extent.

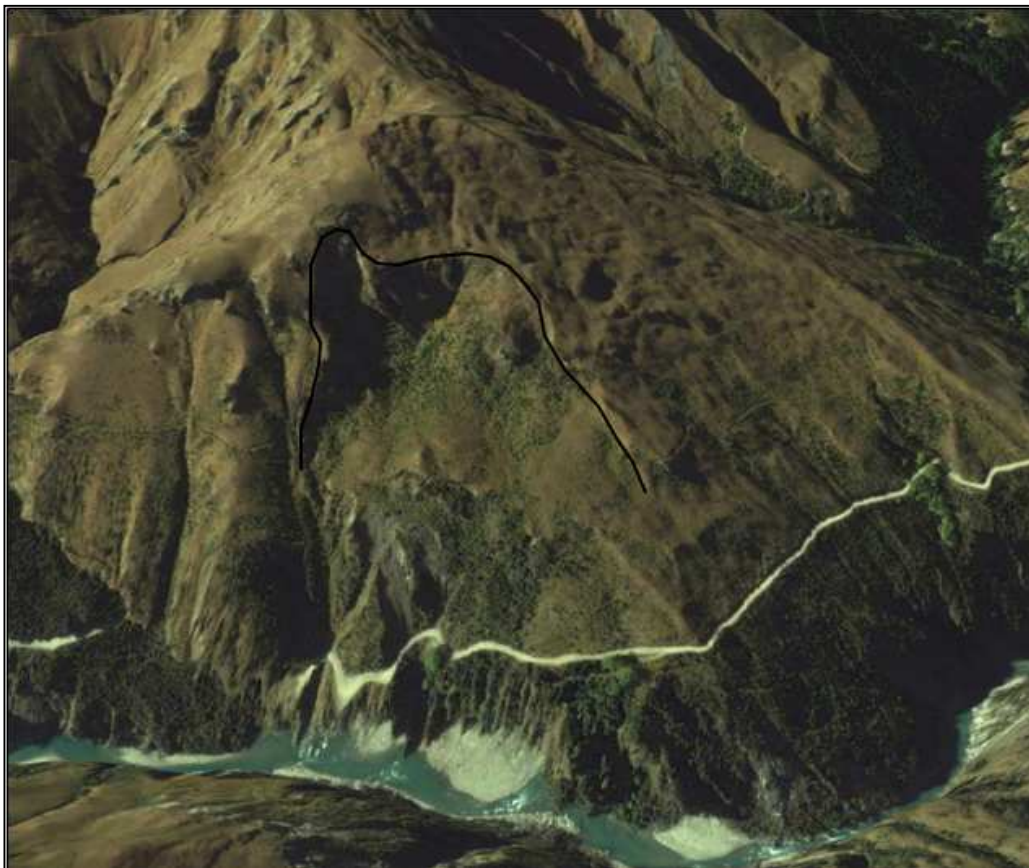
**Figure 2.30:** An example of a creeping landslide with typical rippled deformation, a section of which has progressed to form a rapid failure. This is in the lower Shotover Gorge at Pinchers Bluff, with the rapid failure scarp ~250 m in width outlined (Google Earth 2010).

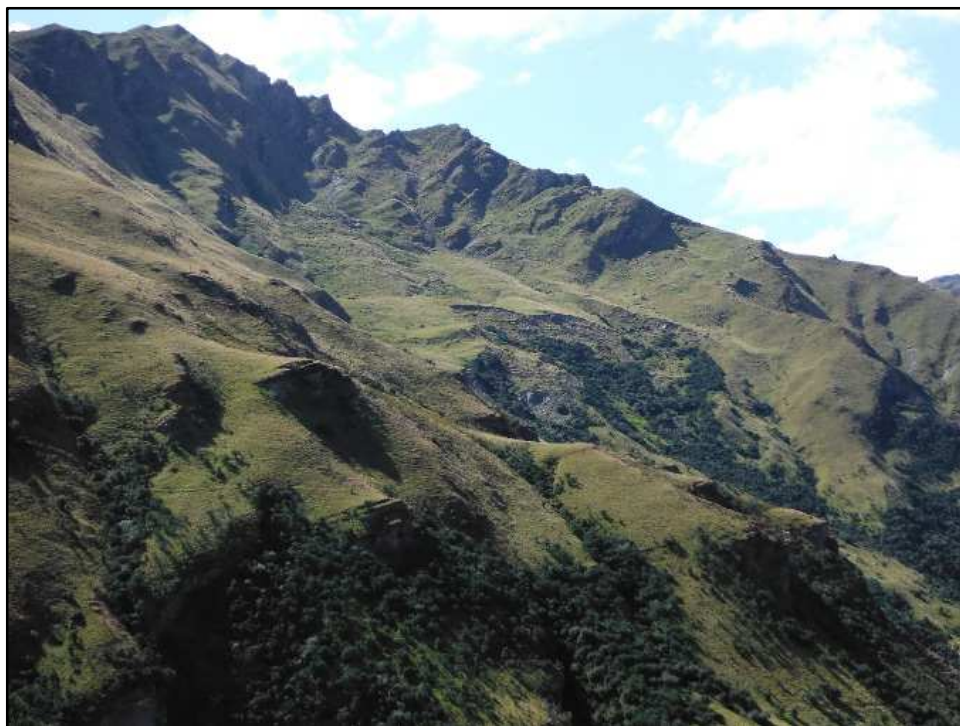
**Figure 2.31:** Large landslide scarp in lower Shotover Gorge, this is located at about McCarrons Beach and has a scarp width of about 500 m.

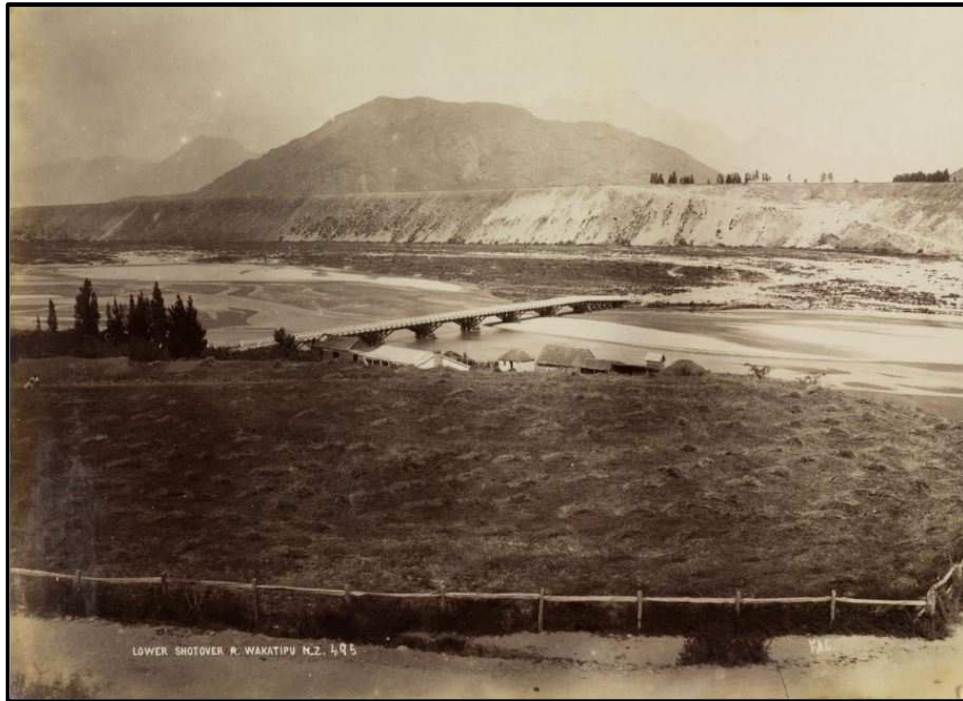
**Figure 4.4:** The first lower Shotover Bridge, showing upper Shotover Delta prior to peak aggradation levels. View is looking southwest towards what is now the location of the WWTP (Hocken Library).

During the aggradation phase of this sediment pulse, the riverbed rose and expanded in width, for example seen in photographs (Figures 4.4, 4.5) and surveys (Figure 4.6) at the Shotover Delta. As the sediment supply subsequently decreased, a degradation phase commenced, with incision and narrowing of the active riverbed, and revegetation of former aggradation surface (e.g. Figures 4.9, 4.10). Degradation may still be ongoing, with the lower Shotover River still incising as recently as 2012-2014, seen in survey data at the Bowen's peak flow gauging station (Figure 4.11), and cross sections at the Shotover Delta (Figure 4.12). The incising channel level may now have attained or be near to the pre-mining channel, however a large volume of the excess sediment remains stored as floodplain terrace deposits and continues to be eroded and mobilised by flood events, forming minor pulses in riverbed level (e.g. Figure 4.11). The large volume of stored sediments means there is now less vacant storage volume than prior to mining, and so the next major sediment input will cause more rapid and higher aggradation.

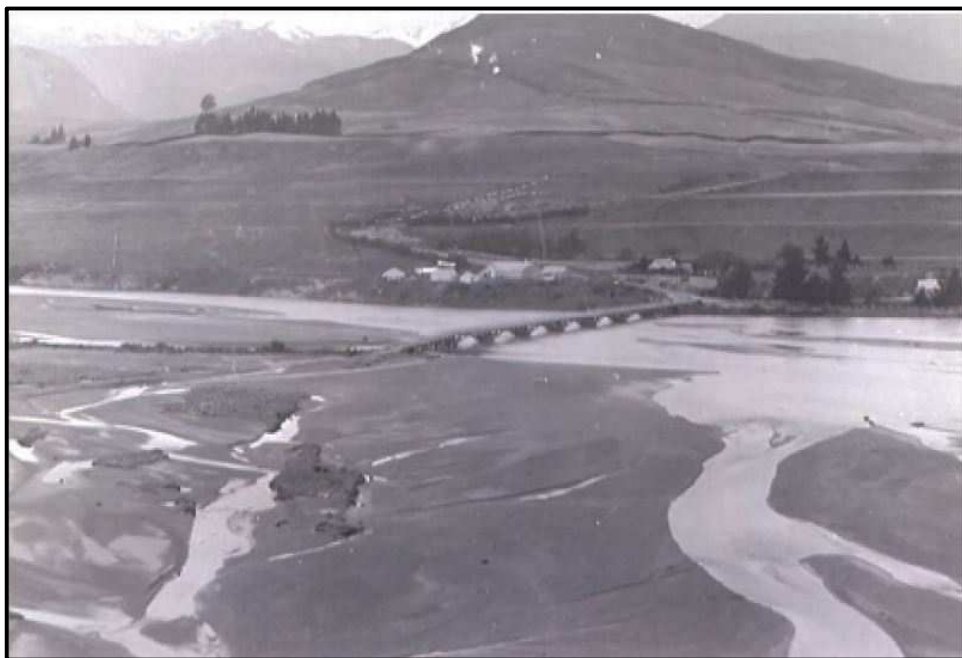
**Figure 4.5:** A later image (1890s-1912) shows active alluvium and river channels across entire width of the upper Shotover delta and covering of all vegetation seen in earlier photo. View is looking northeast towards Slope Hill (Shotover Country website).

Riverbed changes at the Shotover Delta are significant due to the strong influence the delta morphology has on Kawarau River outflows and flooding of Lake Wakatipu. As with the rest of the lower Shotover River, the delta aggraded during the historic mining period, as was noted by many reports and seen in surveys (Figure 4.6) and photographs (Figure 4.5) of the delta and lower Shotover bridges.

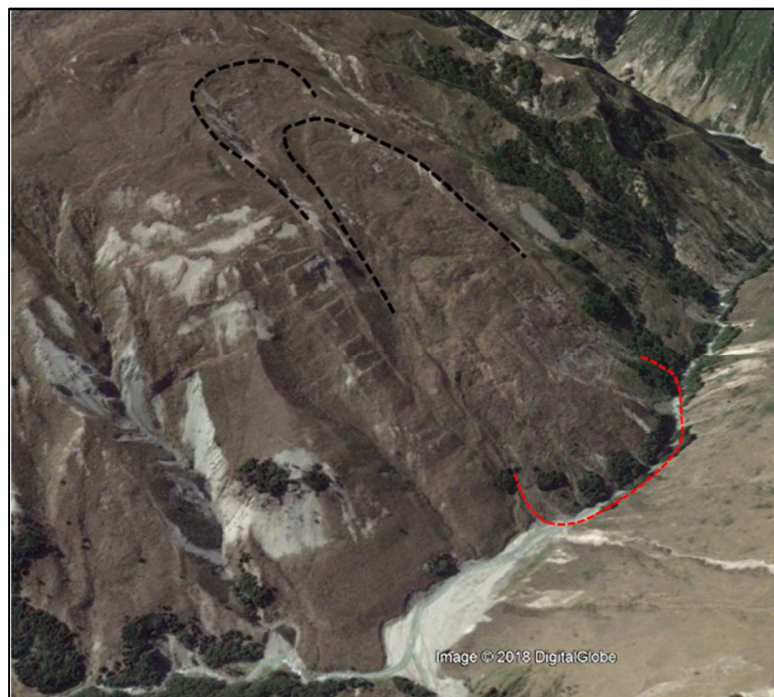
**Figure 6. 2** Example of a low-displacement type landslide dam, located in the Upper Moonlight Creek, labelled as 18 in Figure 6.13. This landslide is about 280 metres in width and may have a volume of >5M m<sup>3</sup>. Constriction of the valley has formed a broad alluvial flat upstream of this dam (lower centre). Figure shows interpreted outline of landslide scarp (black dashed line) and the resulting deposit (red). (Google Earth 2010).

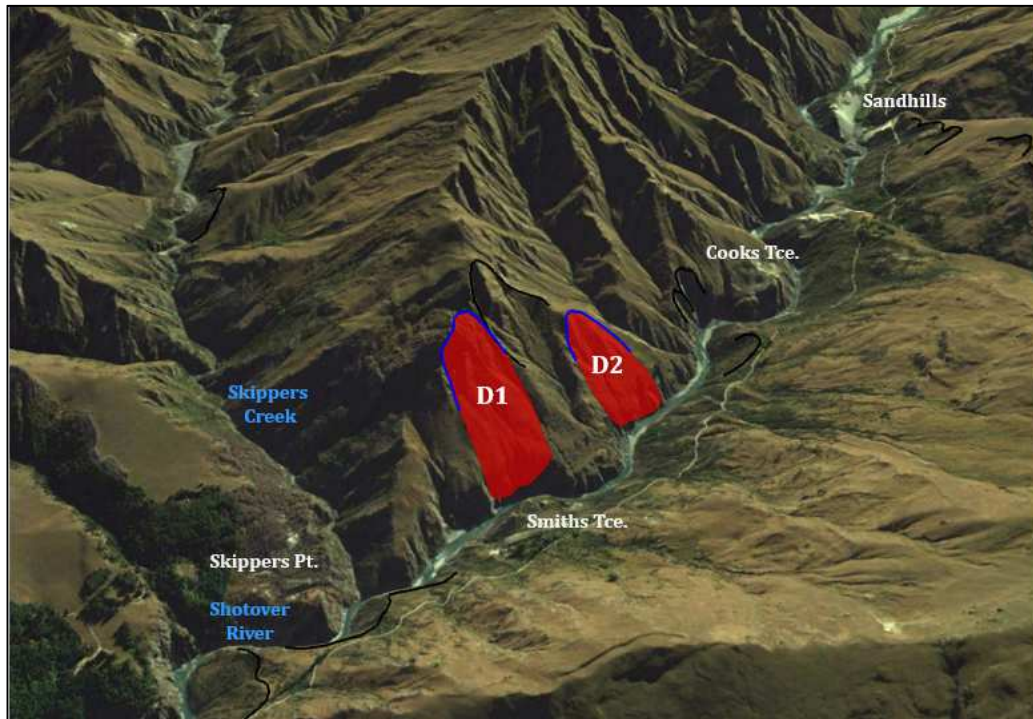
**Figure 6. 4C** Oblique view of upper Shotover Gorge (Zone D) landslide scenarios. View is towards the northwest. Black outlines indicate existing landslide scarps. (Google Earth 2010).

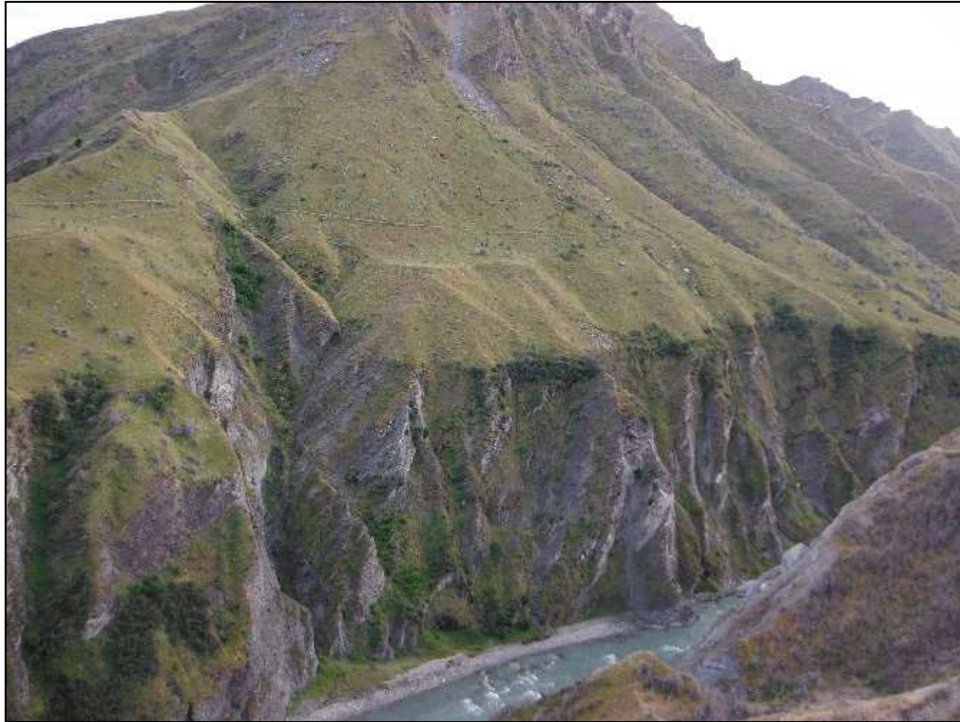
**Figure 6. 6** Example of slope undercutting in the upper Shotover Gorge at about the location of scenario D1. The steep cliffs are 80-90 m in height and are interpreted to have formed by fluvial incision during the postglacial period.

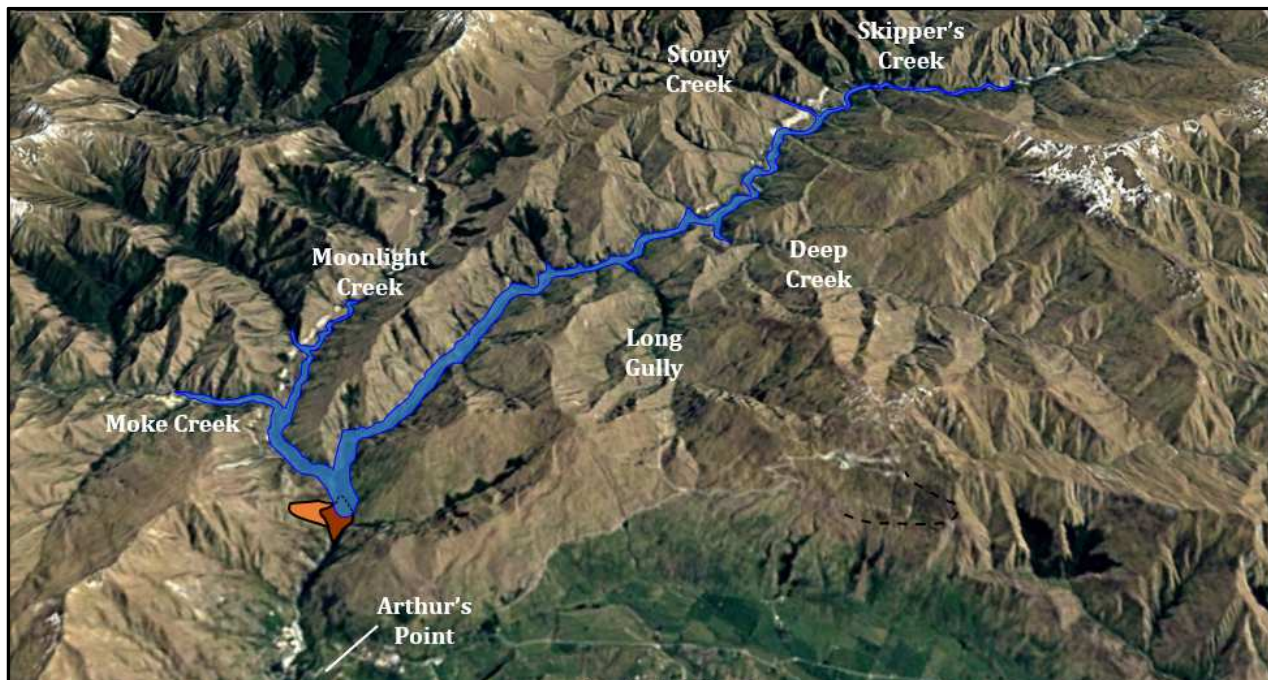
**Figure 9.2:** Extent of a landslide-dammed lake, formed by a lower Shotover Gorge landslide dam scenario. View is looking upvalley from about the Wakatipu Basin (Google Earth).

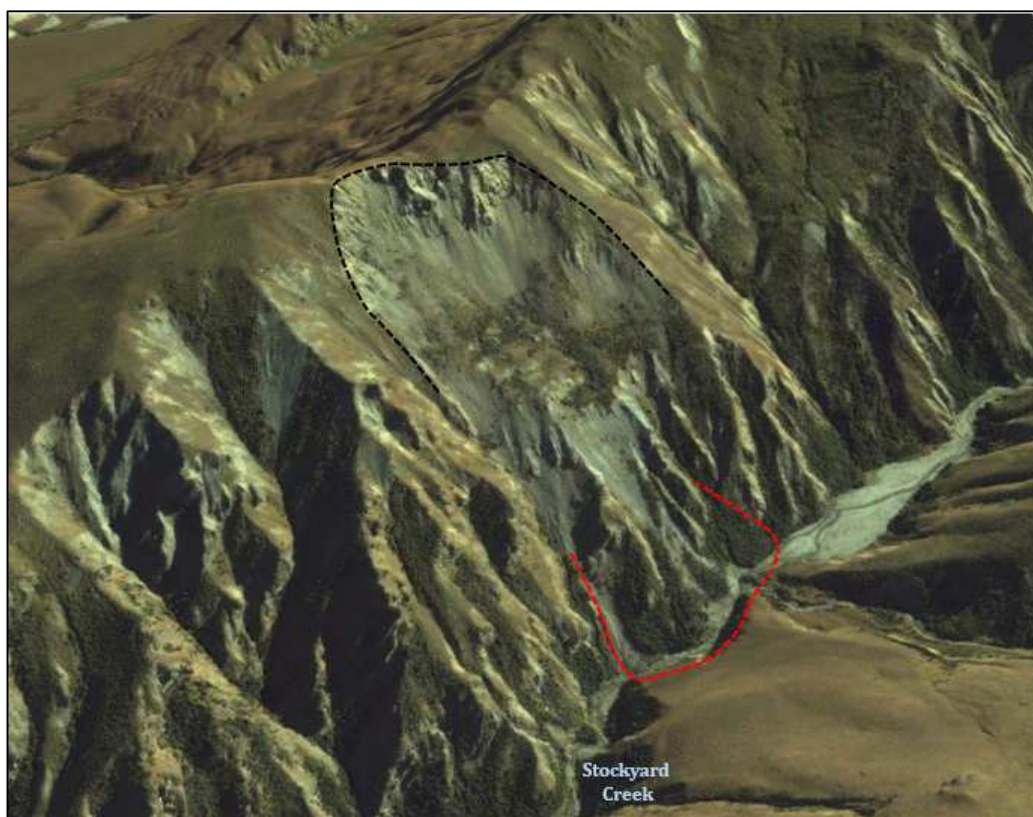
**Figure 10.8:** Example of landslide dam morphology at Stockyard Creek, showing the landslide scarp and deposit, with a small alluvial flat developed from upstream aggradation. This landslide scarp is about 270 m in width, and located approximately 2.4 km upstream from Branches Flat.

At the landslide dam location, debris is gradually eroded during high flow events, and the dam's form becomes less distinct over decades or hundreds of years as it becomes more topographically subdued and vegetated. As the dam remnants become less recognisable, the former dam location can still be identified as a diagnostic knickpoint in the channel profile. Such features commonly comprise a steeper boulder-armoured rapid in the channel, with shallow gradient alluvial flats upstream. Examples of former landslide morphology elsewhere in the Shotover Catchment are seen in Appendix 3. These include sites with well-defined landslide scarps, remnant dams, and alluvial flats upstream, such as the Stockyard Creek landslide dam (Figure 10.8). In other locations the landslide scarp and dam-forming deposits are unclear or obscured, but can be interpreted from the stream morphology.

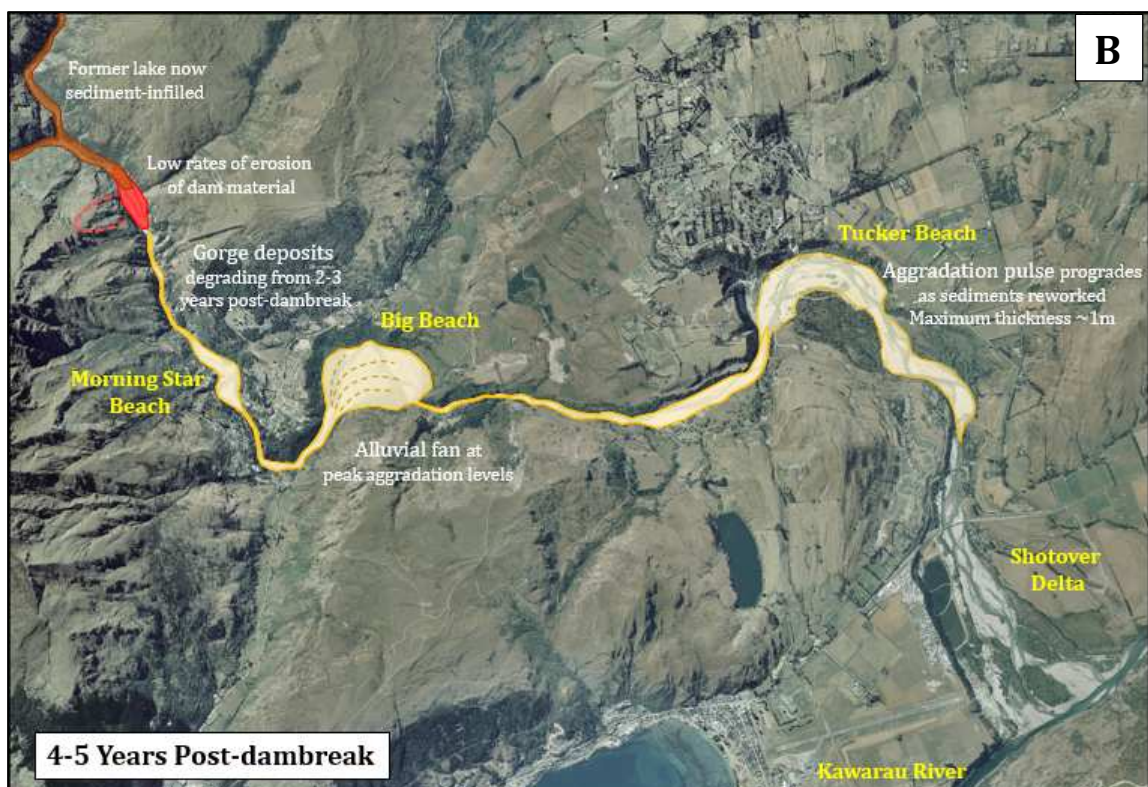
**Figure 10.9:** Aggradation scenario showing geomorphic impacts in the lower Shotover River. These are; A. Immediately after dam breaching showing the distribution of dambreak deposits, B. 4-5 years after the dambreak showing extensive aggradation, and C. 8-10 years after the dambreak, showing widespread degradation in most locations.

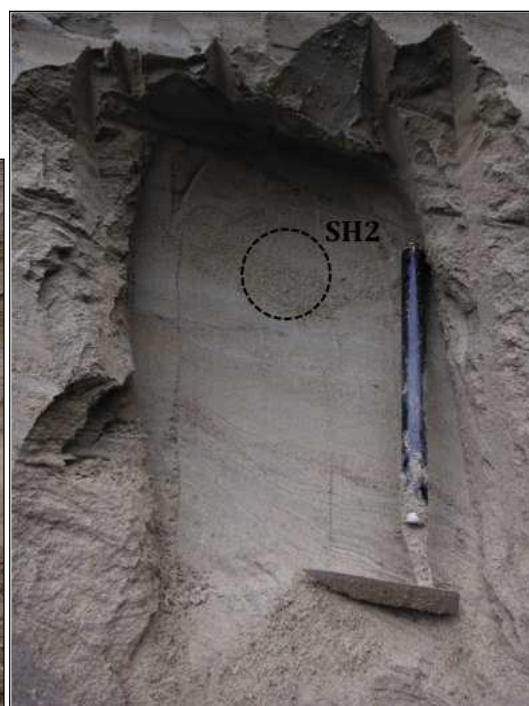
**Figure 4:** Outcrop location (left), and detail of sampled unit for OSL sample SH2 at Sandhill Creek.

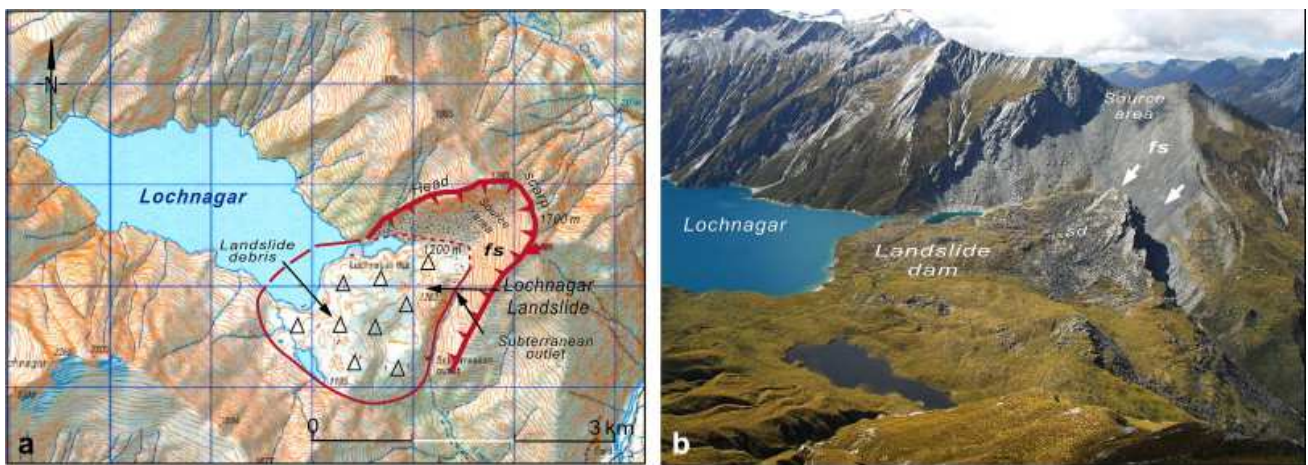
**Figure 1:** Lochnagar landslide dam, showing A. landslide scarp and deposit on topomap, and B. photo of landslide source area and dam. Image: Hancox and Perrin (2009).

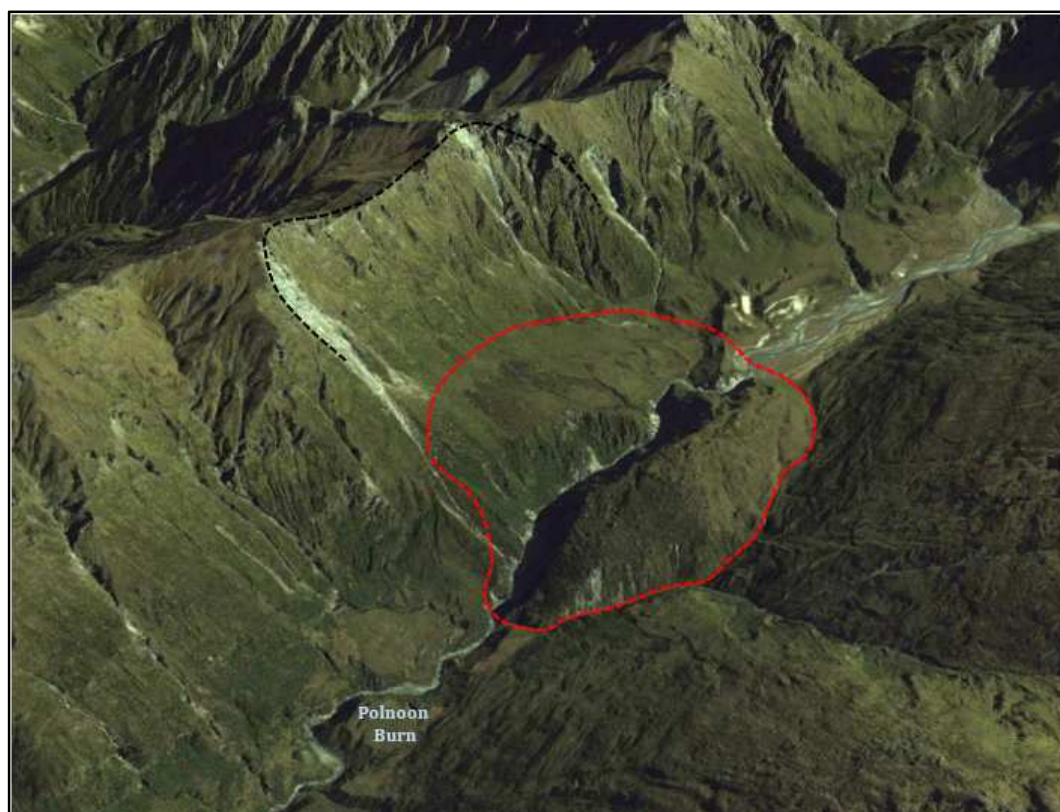
**Figure 2:** Polnoon Burn landslide dam. Showing landslide deposit extending for >1 km along valley, and incised gorge through deposit.

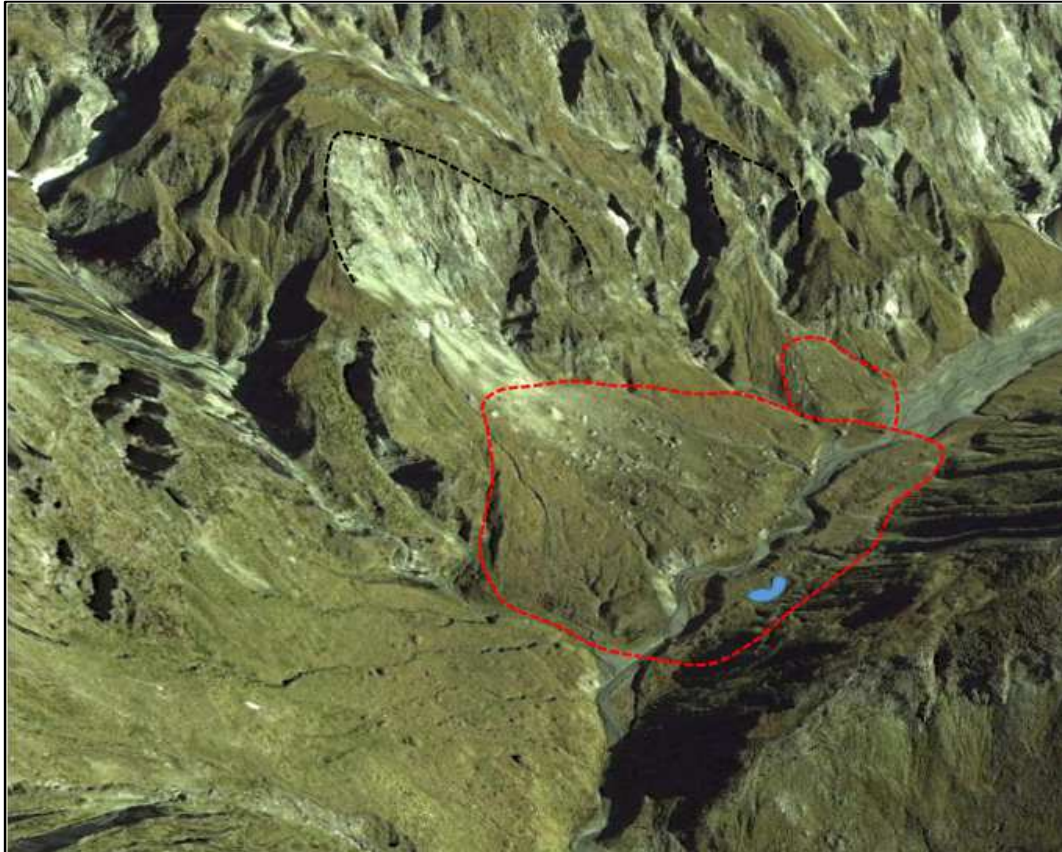
**Figure 3:** Upper Polnoon Burn landslide dam, showing incised channel through landslide deposit and small pond developed. A more recent rockfall has deposited minor debris at base of slope.

This dam has been referenced only in Bryant and Goldsmith (2013). The landslide is about 300 m in width, there appears to be recent rockfall activity with minor, relatively fresh debris seen at the at base of the slope. There is another similar sized landslide immediately downstream, and a smaller slide located ~200 m upstream. These may have also caused channel blockages. A 100 m width scarp from the opposite (eastern) slope may have also contributed to dam material. The creek has partially incised through the dam forming a well-defined terrace on east side of creek, and there is a pond of ~40 m in length formed on dam remnants to east of creek. Immediately upstream from dam is a broad section of braided riverbed (600 m length x 100 m width) showing an infilling of the upstream basin.

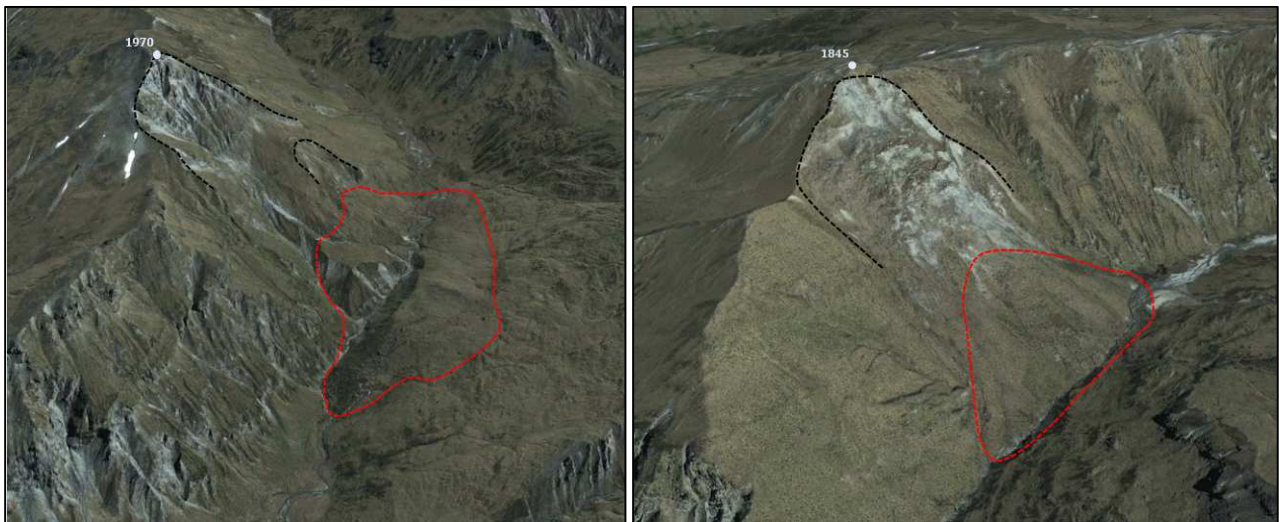
**Figure 4 (left):** Blue Creek (1970), showing large landslide dam deposit and incised gorge.

**Figure 5 (right):** Blue Creek (1845) showing large landslide constricting valley, and alluvial flats developed upstream.

The eastern landslide (from about point '1970') forms a dam in the headwaters of Blue Creek. This landslide appears deeper seated and larger volume, potentially up to  $\sim 10\text{M m}^3$ . The dam has a height of many tens of metres, and extends for  $>900\text{ m}$  along the valley. The valley is relatively wide at this point and the dam may have had a cross-valley width of  $>500\text{ m}$ . The stream has incised a deep channel  $\sim 700\text{ m}$  in length through the dam material. For about  $1500\text{ m}$  upstream the creek is strongly meandering and sediment infilled.

The western landslide (from about point '1845') forms a dam in the main western tributary of Blue Creek, with a volume estimated at  $8\text{M m}^3$  (Korup 2006). The dam height has been estimated at  $30\text{ m}$  (Korup 2006). Has formed a sediment infilled basin for  $\sim 700\text{ m}$  upstream.

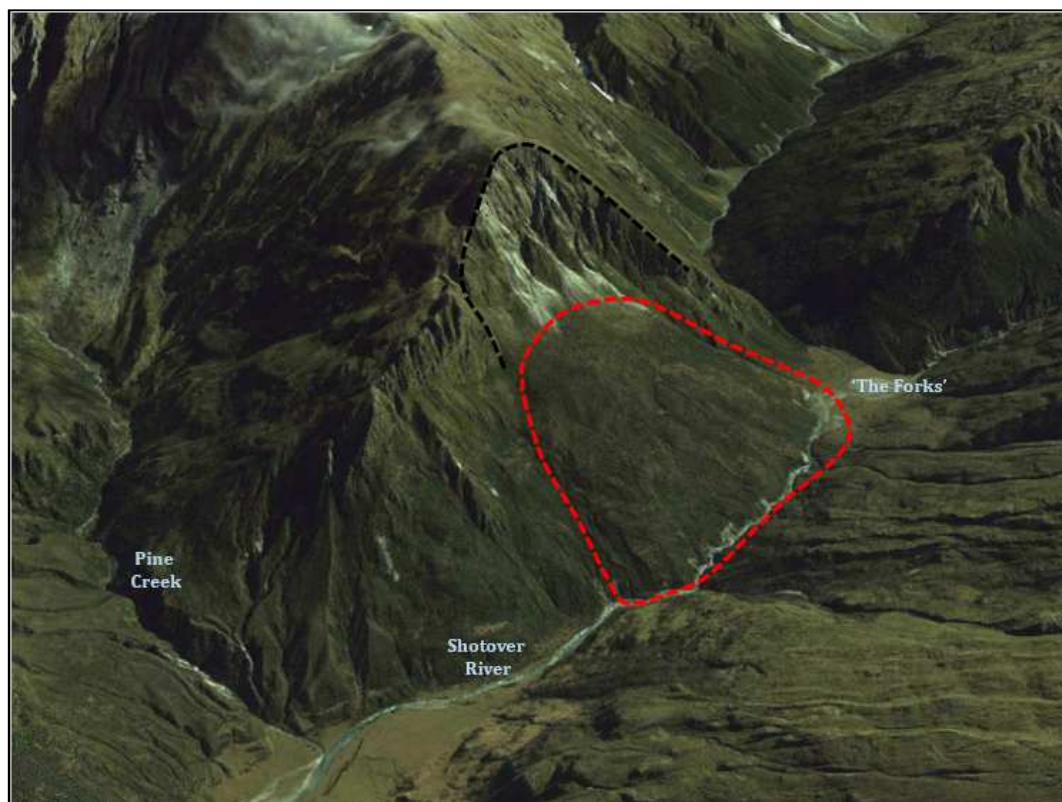
**Figure 6.** Shotover River landslide dam at the Forks.

A large landslide with a width of about 800 m and a volume estimated to be 20-30M m<sup>3</sup>. This landslide and the gorge cutting across landslide deposits was noted by both Brown (1956) and MWD (1975) reports. This large dam has an along-valley length of >1000 m. Upstream of the dam, Junction Flat represents a small sediment-infilled lake (MWD 1975). Steep rapids fall through the landslide dam section of creek, with an estimated elevation drop of 60-70 m.

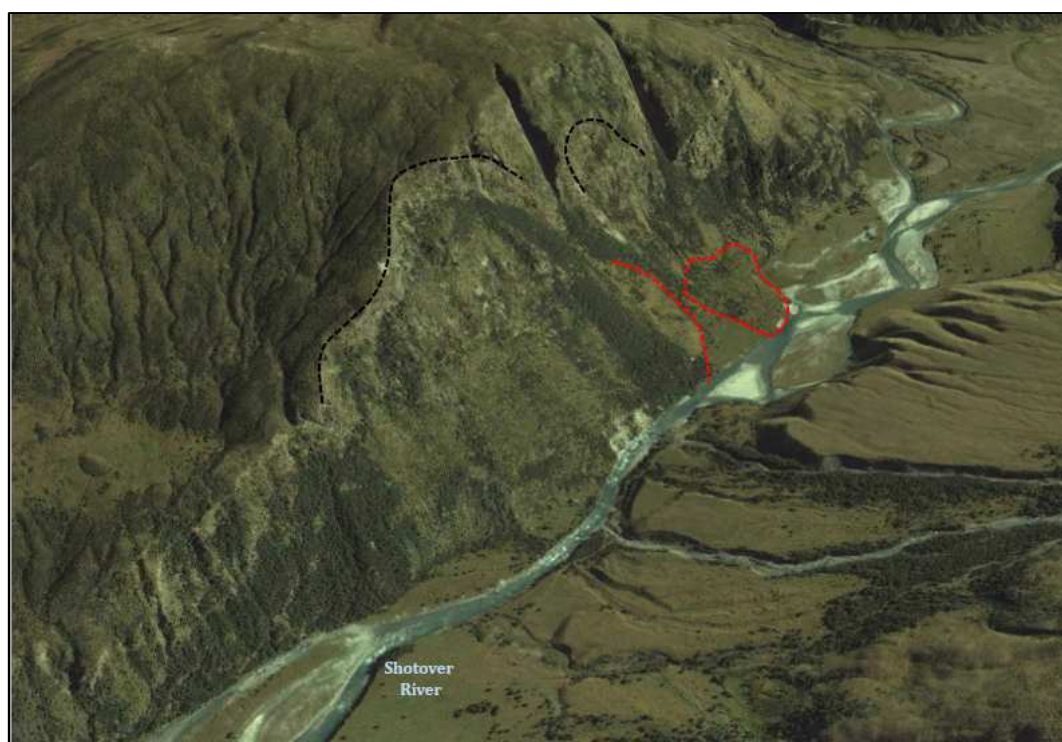
**Figure 7:** Possible Shotover River landslide dam between 17 Mile and Lake Creeks. Landslide scarps can be seen but deposits are unclear.

Located on the Shotover River between 17 Mile Creek and Lake Creeks. Noted in McSaveney (1978, Fig5) where it is shown as two landslides sourced from western slopes. A large landslide scarp about 400 m in width, with a smaller, poorly defined scarp to the north. The main landslide may have a volume of up to about 1.5M m<sup>3</sup>. The remains of any landslide dam formed in this location are not obvious. They may have been largely eroded, or obscured by Shotover River alluvial deposits and the large alluvial fan originating from the creek on the opposite (eastern) side of valley.
